BEYOND LEAK DETECTION

REPORT

Project ID: AQEA-17-0225
Date: June 19, 2018

SUBJECT "Leak Detection Service For Conducting A Monitoring Survey For D&A Consolidated Lagoon 3 Located At D&A Dairy Farm Facility In Outlook, Washington, USA"

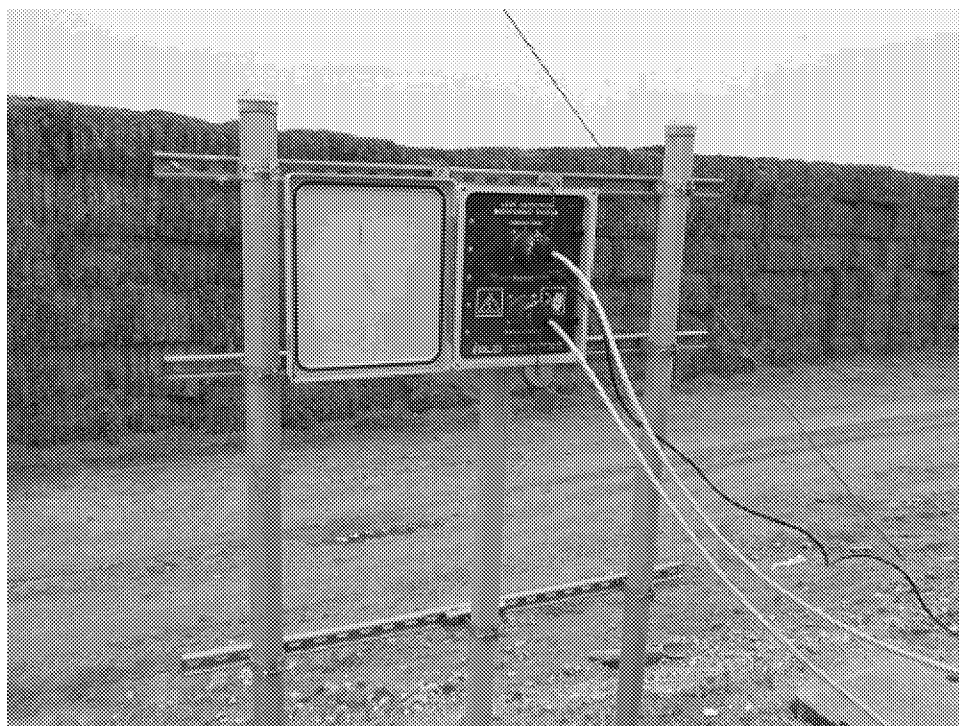
Figure 1. A Typical Interface Setup with the Resistivity Meter at the Measurement Station during the PELM[®] Survey

The PELM5050 System can easily test the integrity of a geomembrane by locating penetrations on the geomembrane. This is accomplished by impressing an excitation voltage between the material above and below the geomembrane with two separate current electrodes. Then electrical potential measurements are collected underneath the geomembrane and referenced to stationary electrodes. Therefore, the geomembrane provides an electrical barrier or isolation between the two current electrodes except where there are leaks or damages in the geomembrane. Electrical current flowing through the leaks in the geomembrane produces localized anomalous areas of high current density near the penetrations, which are detected by potential measurements below the geomembrane. A single channel memory earth resistivity meter and switch box is used to collect the potential measurements or data relative to the geomembrane at measurement stations. After data collection from the meter at the measurement stations is complete, the data is downloaded to a computer for plotting and data analysis. Figure 1 shows a typical interface setup at the measurement station during the PELM[®] survey.

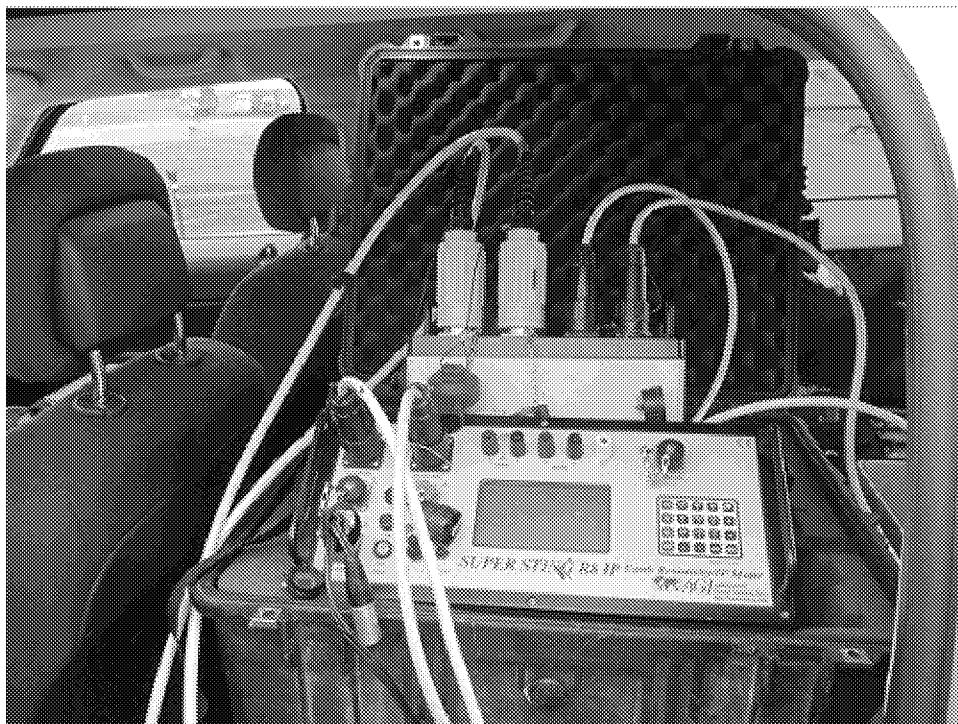
Figure 2. Typical Setup of Resistivity Meter and Switch Box in Vehicle

The unit used to collect data and energize the PELM5050 System was a multi-channel earth resistivity meter, or the SuperSting R8 (SSR8). Only the single-channel functionality was used during the surveys. The meter collects potential measurements through one channel for each measurement cycle, and has the capability to communicate with an Android device during field usage. The meter was connected to a switch box that switches from 84 different electrodes. The system was powered by a deep-cycle 12 volt battery. Figure 2 shows an example of a typical setup of the resistivity meter and switch box during data collection from inside a vehicle. Data collection was downloaded to a PC via SuperSting software and analyzed using the leak detection software.

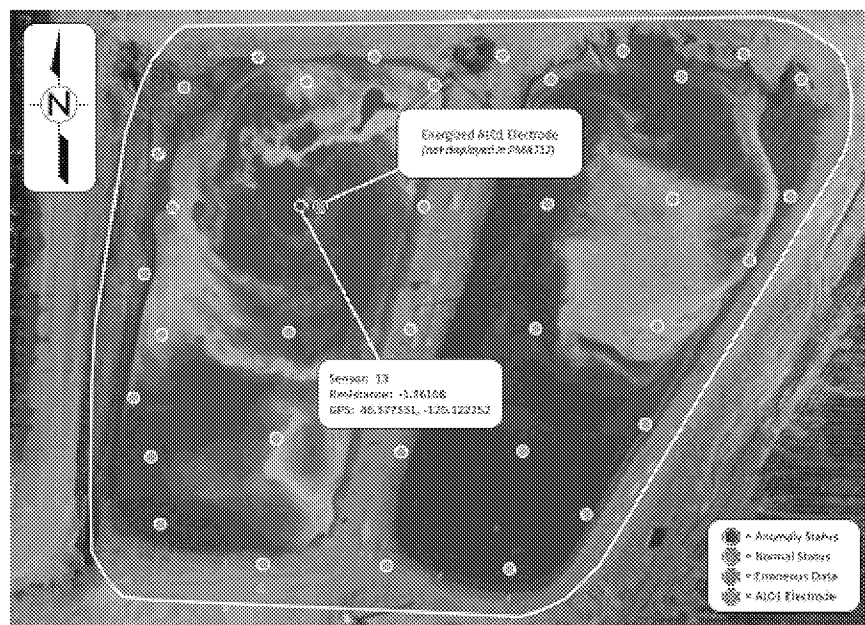
Figure 4. Example of a Sensor Electrode (Sensor 13) Displaying an Anomaly Status (Red) when an Artificial Leak (AL01) is Energized

When analyzing data on the PMAT17 leak detection software, a topographical picture is displayed and outlines the approximate cell perimeter. All sensor electrodes are positioned according to the survey coordinates provided during installation of the system. If any sensor electrodes were recorded below the LTL value, then this would visually notify the user that a potential anomaly may be present via red sensor electrode. In this case, further investigation would be required. The artificial leak electrodes are not displayed on PMAT17 since they are energized sources, and therefore, not used as potential measurement electrodes or devices. Figure 4 shows an example of an artificial leak approximately 1 foot away from a nearby sensor electrode when the artificial leak is energized during the Artificial Leak Test.

All data collected while energizing all artificial leaks displayed the correct functionality and sensitivity of the PELM5050 System. The calibration procedure demonstrated that all artificial leaks were active during data collection. Table 3 lists the energized artificial leaks, their respective nearby sensor electrodes, and the potential measurements.

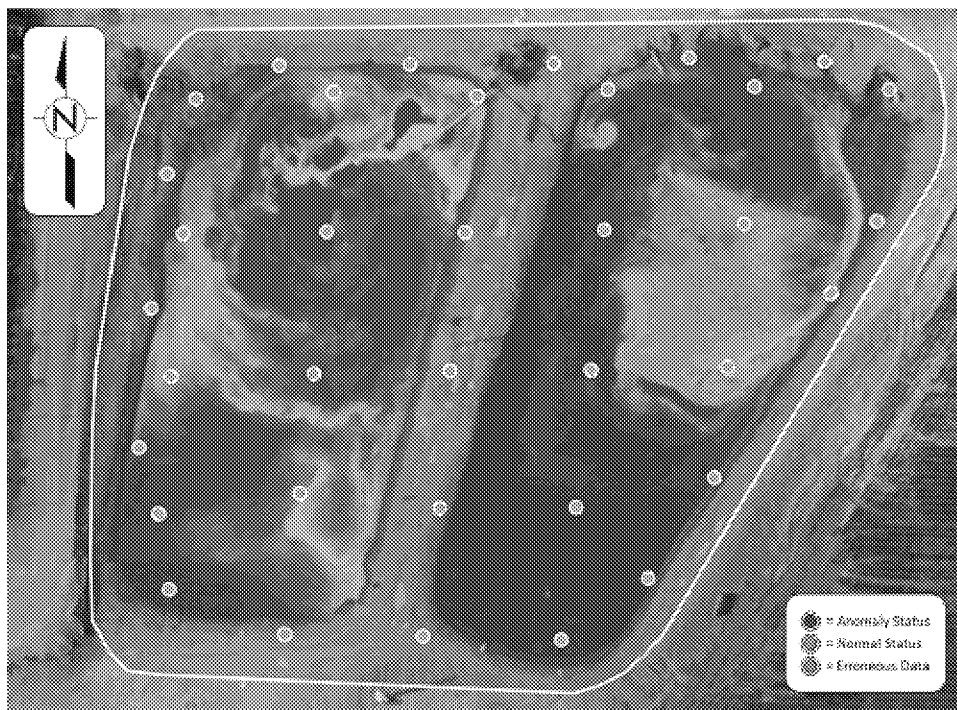
Figure 5. Sensor Electrodes at MS-A with Normal Status for DA-CL3 at D&A Dairy Farm Facility

During the raw data collection process at DA-CL3, all raw data sets showed no suspects of potential anomalies. The data collection was performed with a high voltage output of 400 Volts, and a current setting of 50 milliamps. Currently, this verifies that the liquid in DA-CL3 is contained and that the integrity of the geomembrane has not been compromised. Figure 5 shows the map of electrodes with normal status using PMAT17 for DA-CL3. Table 4 lists the raw set of data collected at MS-A and the resistance value of each sensor electrode.
